Case History

PROJECT SUMMARY

Client	Boral
Location	Brisbane, Queensland
Colour	Light Grey (N35)/Various
Area	Unknown
Installer	The Epoxy Coating Specialists

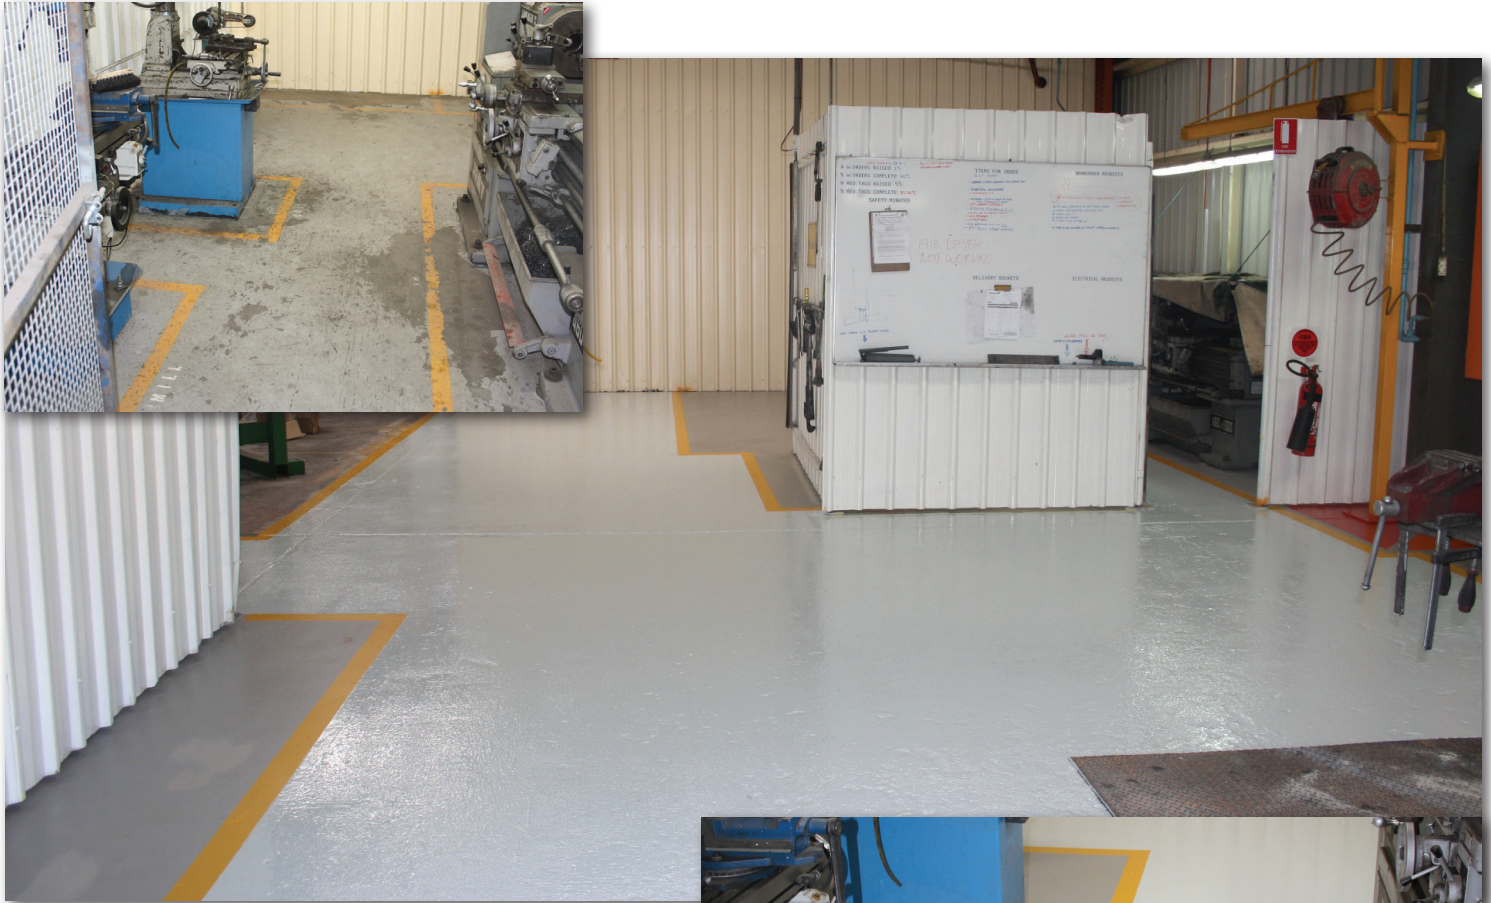
- To prepare and clean the heavily contaminated surface, a high-pressure hot water rotary clean was administered, followed by a diamond grind.
- The Kevlar®-reinforced Jaxxon 1525 was then applied and broadcast with aluminium oxide for a non-slip texture, followed by a topcoat of Jaxxon 1525 to encapsulate the particles and fully seal the floor.
- Also included line marking to make the floor more functional. The light grey colour of the floor not only tidied the appearance of the factory, it also brightened the area considerably.
